University of California Delivers

Staying Afloat with Nontoxic Antifouling Strategies for Boats

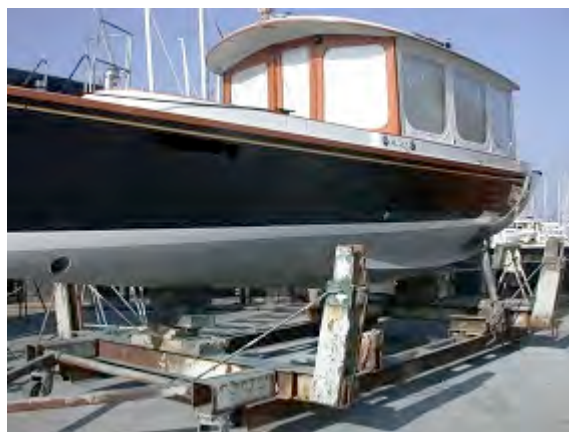
Nontoxic, ceramic-epoxy hull coating in very good condition after 13 months

Marine advisor Leigh Johnson and program representative Jamie Gonzalez conducted San Diego Bay field trials of nontoxic epoxy and ceramic-epoxy hull coatings in 2002 and 2003. The nontoxic coatings were placed on two powerboats and two sailboats. The coatings were cleaned twice monthly by professional hull cleaners who reported coating condition, fouling level, and aggressiveness of cleaning tools and effort. All the coatings performed well and were in good to very good condition after 13 months. Nontoxic coatings were cleaned 26 times per year (twice as often as is typical for cleaning copper paint on San Diego Bay boats). Frequent cleaning allowed hull cleaners to use gentler tools and less effort, reducing damage to the coatings. Johnson and Gonzalez have extended their findings to 3,500 boat owners, boating and coating businesses, agency staff, policy makers and scientists. For details, see their technical report, "Staying Afloat with Nontoxic Antifouling Strategies for Boats" on their Web site - <http://seagrant.ucdavis.edu>.
